**LEESBURG BOARD OF ARCHITECTURAL REVIEW  
STAFF REPORT**

**BAR Case No. TLHP-2012-0072: Replace wood windows with wood windows to match existing, trim to remain.**

**Reviewer:** Kim K. Del Rance, LEED AP  
**Address:** 109 Liberty St NW  
**Zoning:** B-1, H-1 Overlay District  
**Applicant:** Drew Lauten, Lauten Construction  
**Owner:** Stephanie Jones-Carlson

Window list for 109 Liberty St.

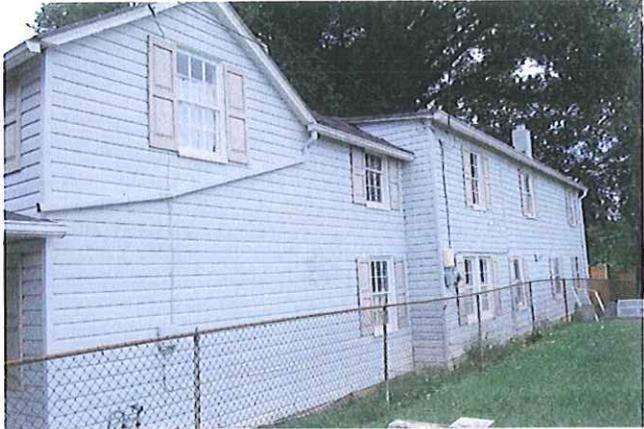
#1

1. 6 over 6 divided light, both sashes sealed shut, muntins in terrible condition, paint flaking off, no method of keeping window open
2. 6 over 6, both sashes sealed shut, muntins in terrible condition, paint peeling off muntins.
3. 6 over 6, sealed shut, paint flaking off, inoperable, muntins damaged
4. 6 over 6, sealed shut, muntins in bad shape, damaged, 2 broken panes of glass, bad seal between sashes, allows air in and out.
5. 6 over 6, sealed shut, inoperable, not original sashes, bad fit in jamb, paint flaking, bad seal around outside of sashes, muntins damaged
6. 6 over 6, sealed shut inoperable, not original sashes, bad fit, paint flaking, bad seal
7. 6 light fixed, damaged muntins, paint flaking, bad fit in opening, not original.
8. 6 light fixed, damaged muntins, paint flaking, bad fit in opening, not original.

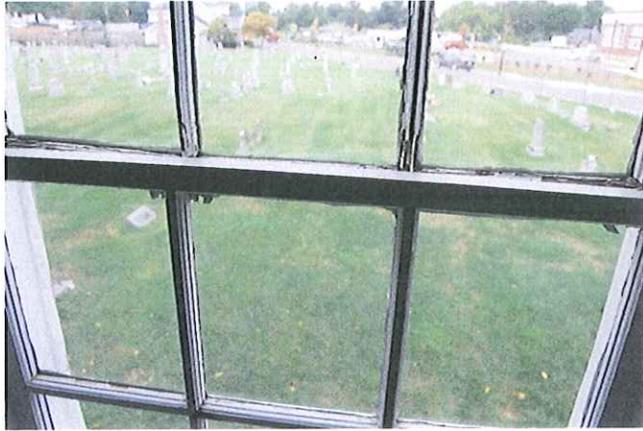
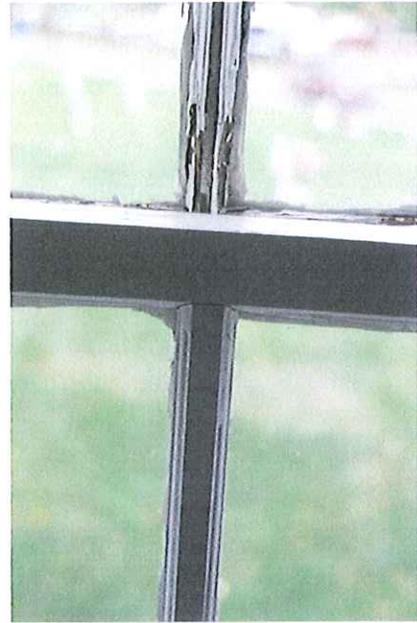
#9

9. 6 over 6, sealed shut, top sash damaged, paint flaking, loose muntins, bottom sash not original, bottom sash does not match top sash.
10. 3 over 6, sealed shut, bottom sash in terrible condition, paint flaking, rotten wood, sash does not match opening, extension built on side of sash.
11. 6 over 6, sealed shut, paint flaking, upper sash is falling apart, drafty, both sashes are replacement
12. 3 over 6, sealed shut, paint flaking.
13. 3 over 6, sealed shut, paint flaking off.
14. 6 over 6, terrible condition, sealed shut, flaking paint, loose muntins.
15. 3 over 6, nailed and sealed shut, paint flaking off, replacement stop moulding.
16. 6 over 6, sealed shut, damaged bottom sash, broken pane of glass.
