**LEESBURG BOARD OF ARCHITECTURAL REVIEW  
STAFF REPORT**

**PUBLIC HEARING AND WORK SESSION: 01 OCTOBER 2012  
AGENDA ITEM 5b**

**BAR Case No. TLHP-2012-0072: Replace wood windows with wood windows to match existing, trim to remain.**

**Reviewer:** Kim K. Del Rance, LEED AP  
**Address:** 109 Liberty St NW  
**Zoning:** B-1, H-1 Overlay District  
**Applicant:** Drew Lauten, Lauten Construction  
**Owner:** Stephanie Jones-Carlson

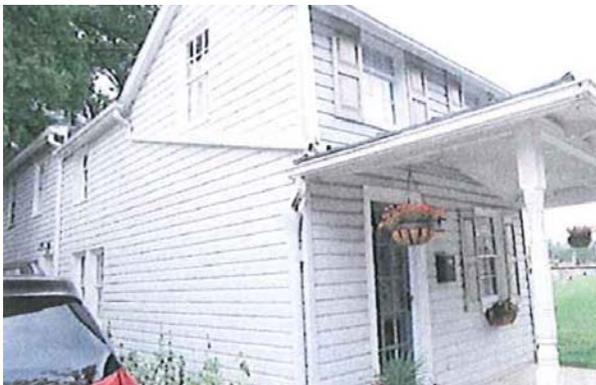
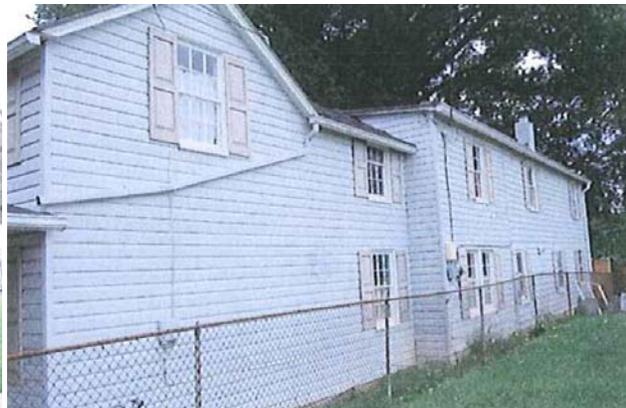
After site visit at September 17, 2012 meeting, applicant agreed to consider restoring some windows and replacing others of the total of 17 wood divided lite windows and to restore the front door, but replace 2 wood side doors (one of which is a replacement door) with wood doors to match the existing. While cost cannot be a primary consideration, the sheer volume of windows to be replaced or restored and the fact that the lead paint is a hazard when the windows are in operation, many of which are now painted or nailed shut, brings livability and therefore some aspects of affordable repairs or replacement into the discussion.

The remaining windows are repairable; however, their age and condition vary depending on when the addition they are installed in was built and the severity of damage caused by weather since installation. The owners are encouraged to seek window restoration that can meet their needs and requirements for as many of the remaining windows as are practical.

- The front door and all three (3) front façade windows, the two (2) front gable windows and all fixed windows shall not be replaced, but the treatment (abatement or restoration) of the windows shall be left to the owner's discretion as long as one window is made operable for a child in an emergency situation in the room planned to be children's bedrooms.
