**LEESBURG BOARD OF ARCHITECTURAL REVIEW  
STAFF REPORT**

**BAR Case No. TLHP-2012-0072: Replace wood windows with wood windows to match existing, trim to remain.**

**Reviewer:** Kim K. Del Rance, LEED AP  
**Address:** 109 Liberty St NW  
**Zoning:** B-1, H-1 Overlay District  
**Applicant:** Drew Lauten, Lauten Construction  
**Owner:** Stephanie Jones-Carlson

Window list for 109 Liberty St.

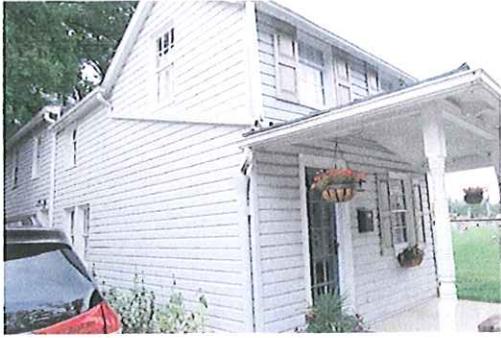
109 Liberty Street NW

view from SE

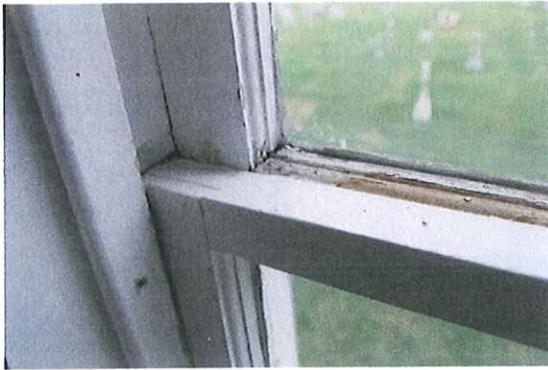
#13

9. 6 over 6, sealed shut, top sash damaged, paint flaking, loose muntins, bottom sash not original, bottom sash does not match top sash.
10. 3 over 6, sealed shut, bottom sash in terrible condition, paint flaking, rotten wood, sash does not match opening, extension built on side of sash.
11. 6 over 6, sealed shut, paint flaking, upper sash is falling apart, drafty, both sashes are replacement
12. 3 over 6, sealed shut, paint flaking.
13. 3 over 6, sealed shut, paint flaking off.
14. 6 over 6, terrible condition, sealed shut, flaking paint, loose muntins.
15. 3 over 6, nailed and sealed shut, paint flaking off, replacement stop moulding.
16. 6 over 6, sealed shut, damaged bottom sash, broken pane of glass.
