LEESBURG BOARD OF ARCHITECTURAL REVIEW STAFF REPORT

**PUBLIC HEARING: 19 DECEMBER 2011
AGENDA ITEM 6B**

**THLP-2011-0077
15 Liberty Street SW, H-1 Overlay District
Fabian E. Saidi, Applicant
Fabian E. Saidi, Owner
Building/Contractor: NA**

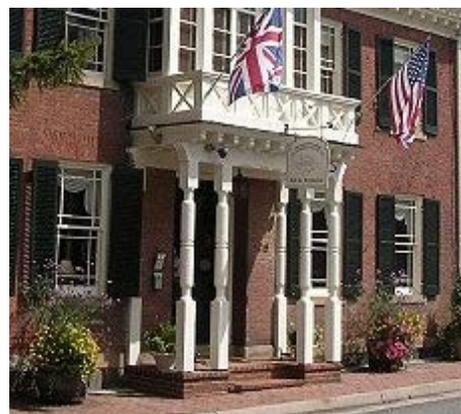
Brought before the BAR as a result of enforcement action, the project involves the installation of vinyl lattice on the front and sides of an open porch on the façade of the building at 15 Liberty Street SW. The lattice is approximately 36 inches high and mounted on a wood frame that was constructed between the historic turned porch posts that support the enclosed second story overhang. The lattice is white, and the trim is painted white to match the rest of the trim on the building. The lattice features a grained texture and is constructed all of a piece; in other words, it does not feature the traditional overlap that results from installing lattice strips diagonally over one another.

Open porches such as the one at 15 Liberty Street SW are not uncommon in the Old and Historic District and are most common when the porch is low to the ground. In fact, they may be found on several historic dwellings that date from the late nineteenth century. A similar (though more ornate) example may be seen less than a block away at the Norris House Inn (108 Loudoun Street SW), where a Queen Anne-style porch was added in the 1880s or 1890s to an early-nineteenth-century Federal-style building (pictured right). Other examples may be seen at 206 Loudoun Street SW, 109 South King Street, and on North King Street. In Leesburg, they appear to be more prevalent when the building abuts the right-of-way or sidewalk.

Neither is the railing designed in a manner that is consistent with traditional porch railings in the Old and Historic District. Were the BAR to determine that the installation of a railing is appropriate in this case, the railing might be considered appropriate if it were: lower and rising only to a height consistent with the top of the square-edged base of the columns and incorporating a traditional hand rail, base rail, and turned or square balusters that butt into the hand and base rails rather than overlapping them as in modern deck construction. Furthermore, the use of lattice on a porch railing has no precedence in Leesburg's architectural history. As installed, the railing is modern and does not reflect the traditional design or construction techniques found on the rest of the building.

Finally, the material used for the railing is inappropriate because it does not convey the visual characteristics of traditional materials. Beyond the fact that lattice has no basis as a porch railing material in the Old and Historic District—which, in and of itself, makes it inappropriate in this application—the material is clearly a thin plastic lattice that does not feature the shadow lines that one expects with a traditionally installed lattice screening.

I move to deny the request presented in TLHP-2011-0077. Furthermore, I move that the applicant be required to return the porch to its original character with the understanding that, should the applicant wish to install an alternate railing on the porch, the dimensions, design, and materials be based on traditional design and consistent with the guidelines for porches on page 61 of the Old and Historic Design Guidelines, and an application will be submitted to and approved by the Board of Architectural Review prior to installation.
